USACERL Technical Report 99/36 April 1999

Ceramic Coated Piston Rods for Civil Works

Robert A. Weber and Raymond Zatorski

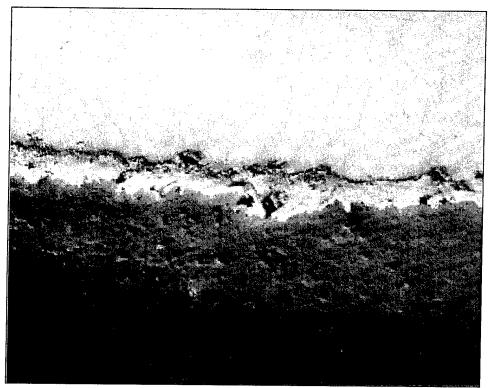
Figure 3. Cross section of alumina-40% titania coating with nickel-chrome interlayer and no seal coat (Specimen 3).

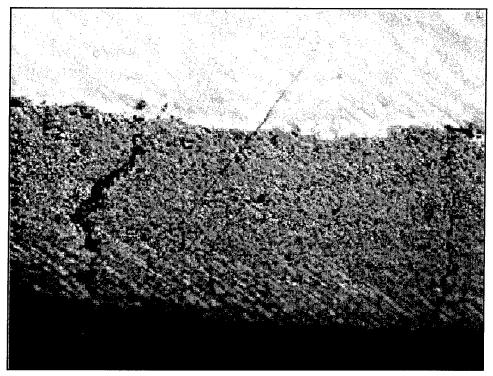
Figure 8. Cross section of chromia coating with no interlayer and no seal coat (Specimen 8).

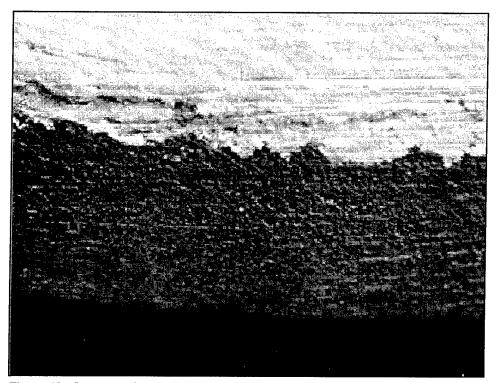
Figure 12. Cross section of alumina-13% titania coating with nickel-aluminum HVOC interlayer and no seal coat (Specimen 12).
